The Chesapeake Bay Breakwater Database Project Hurricane Isabel Impacts to Four Breakwater Systems

Shoreline Studies Program
Virginia Institute of Marine Science
College of William & Mary

May 2005

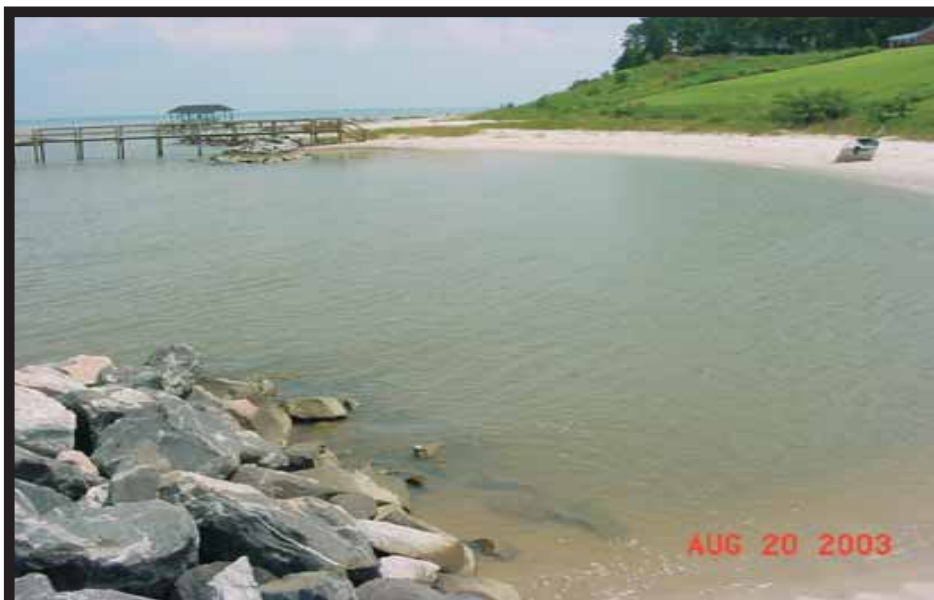
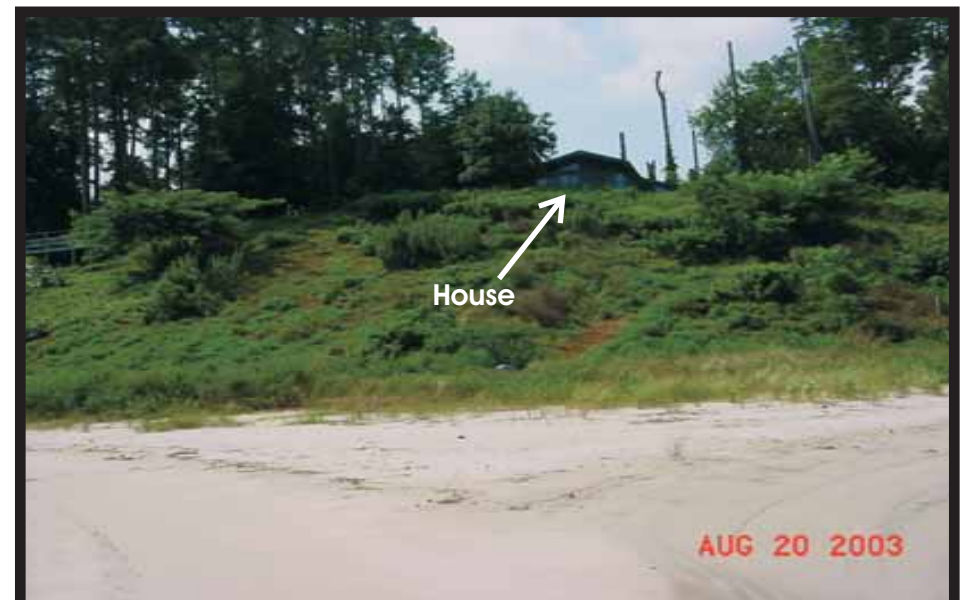
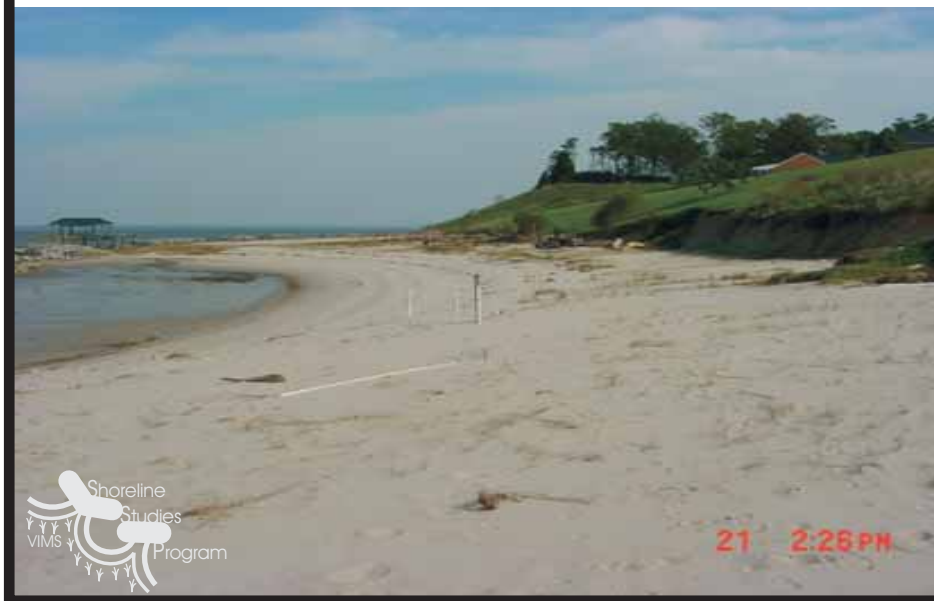
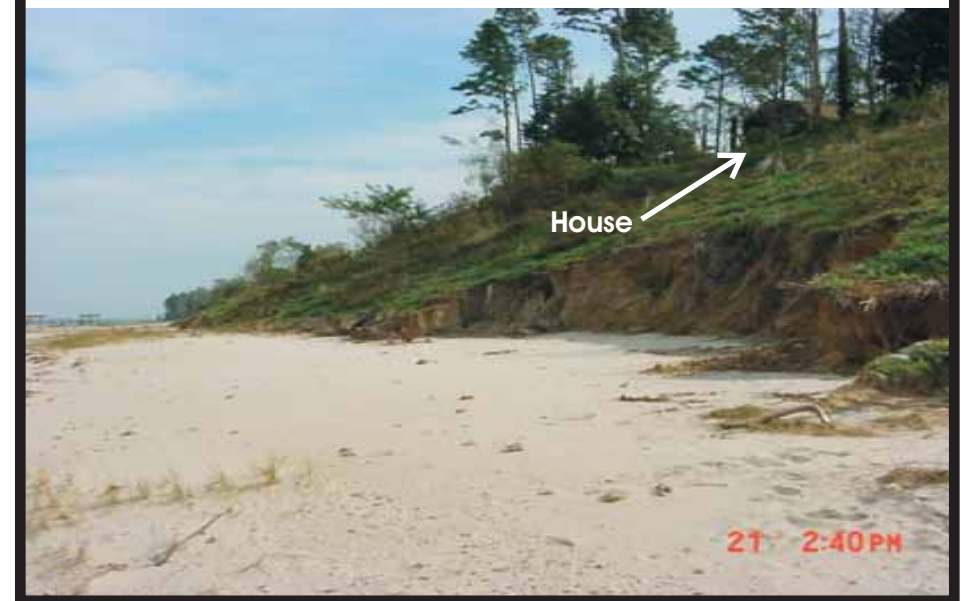
Figure 25. Van Dyke ground photos before and after Hurricane Isabel.

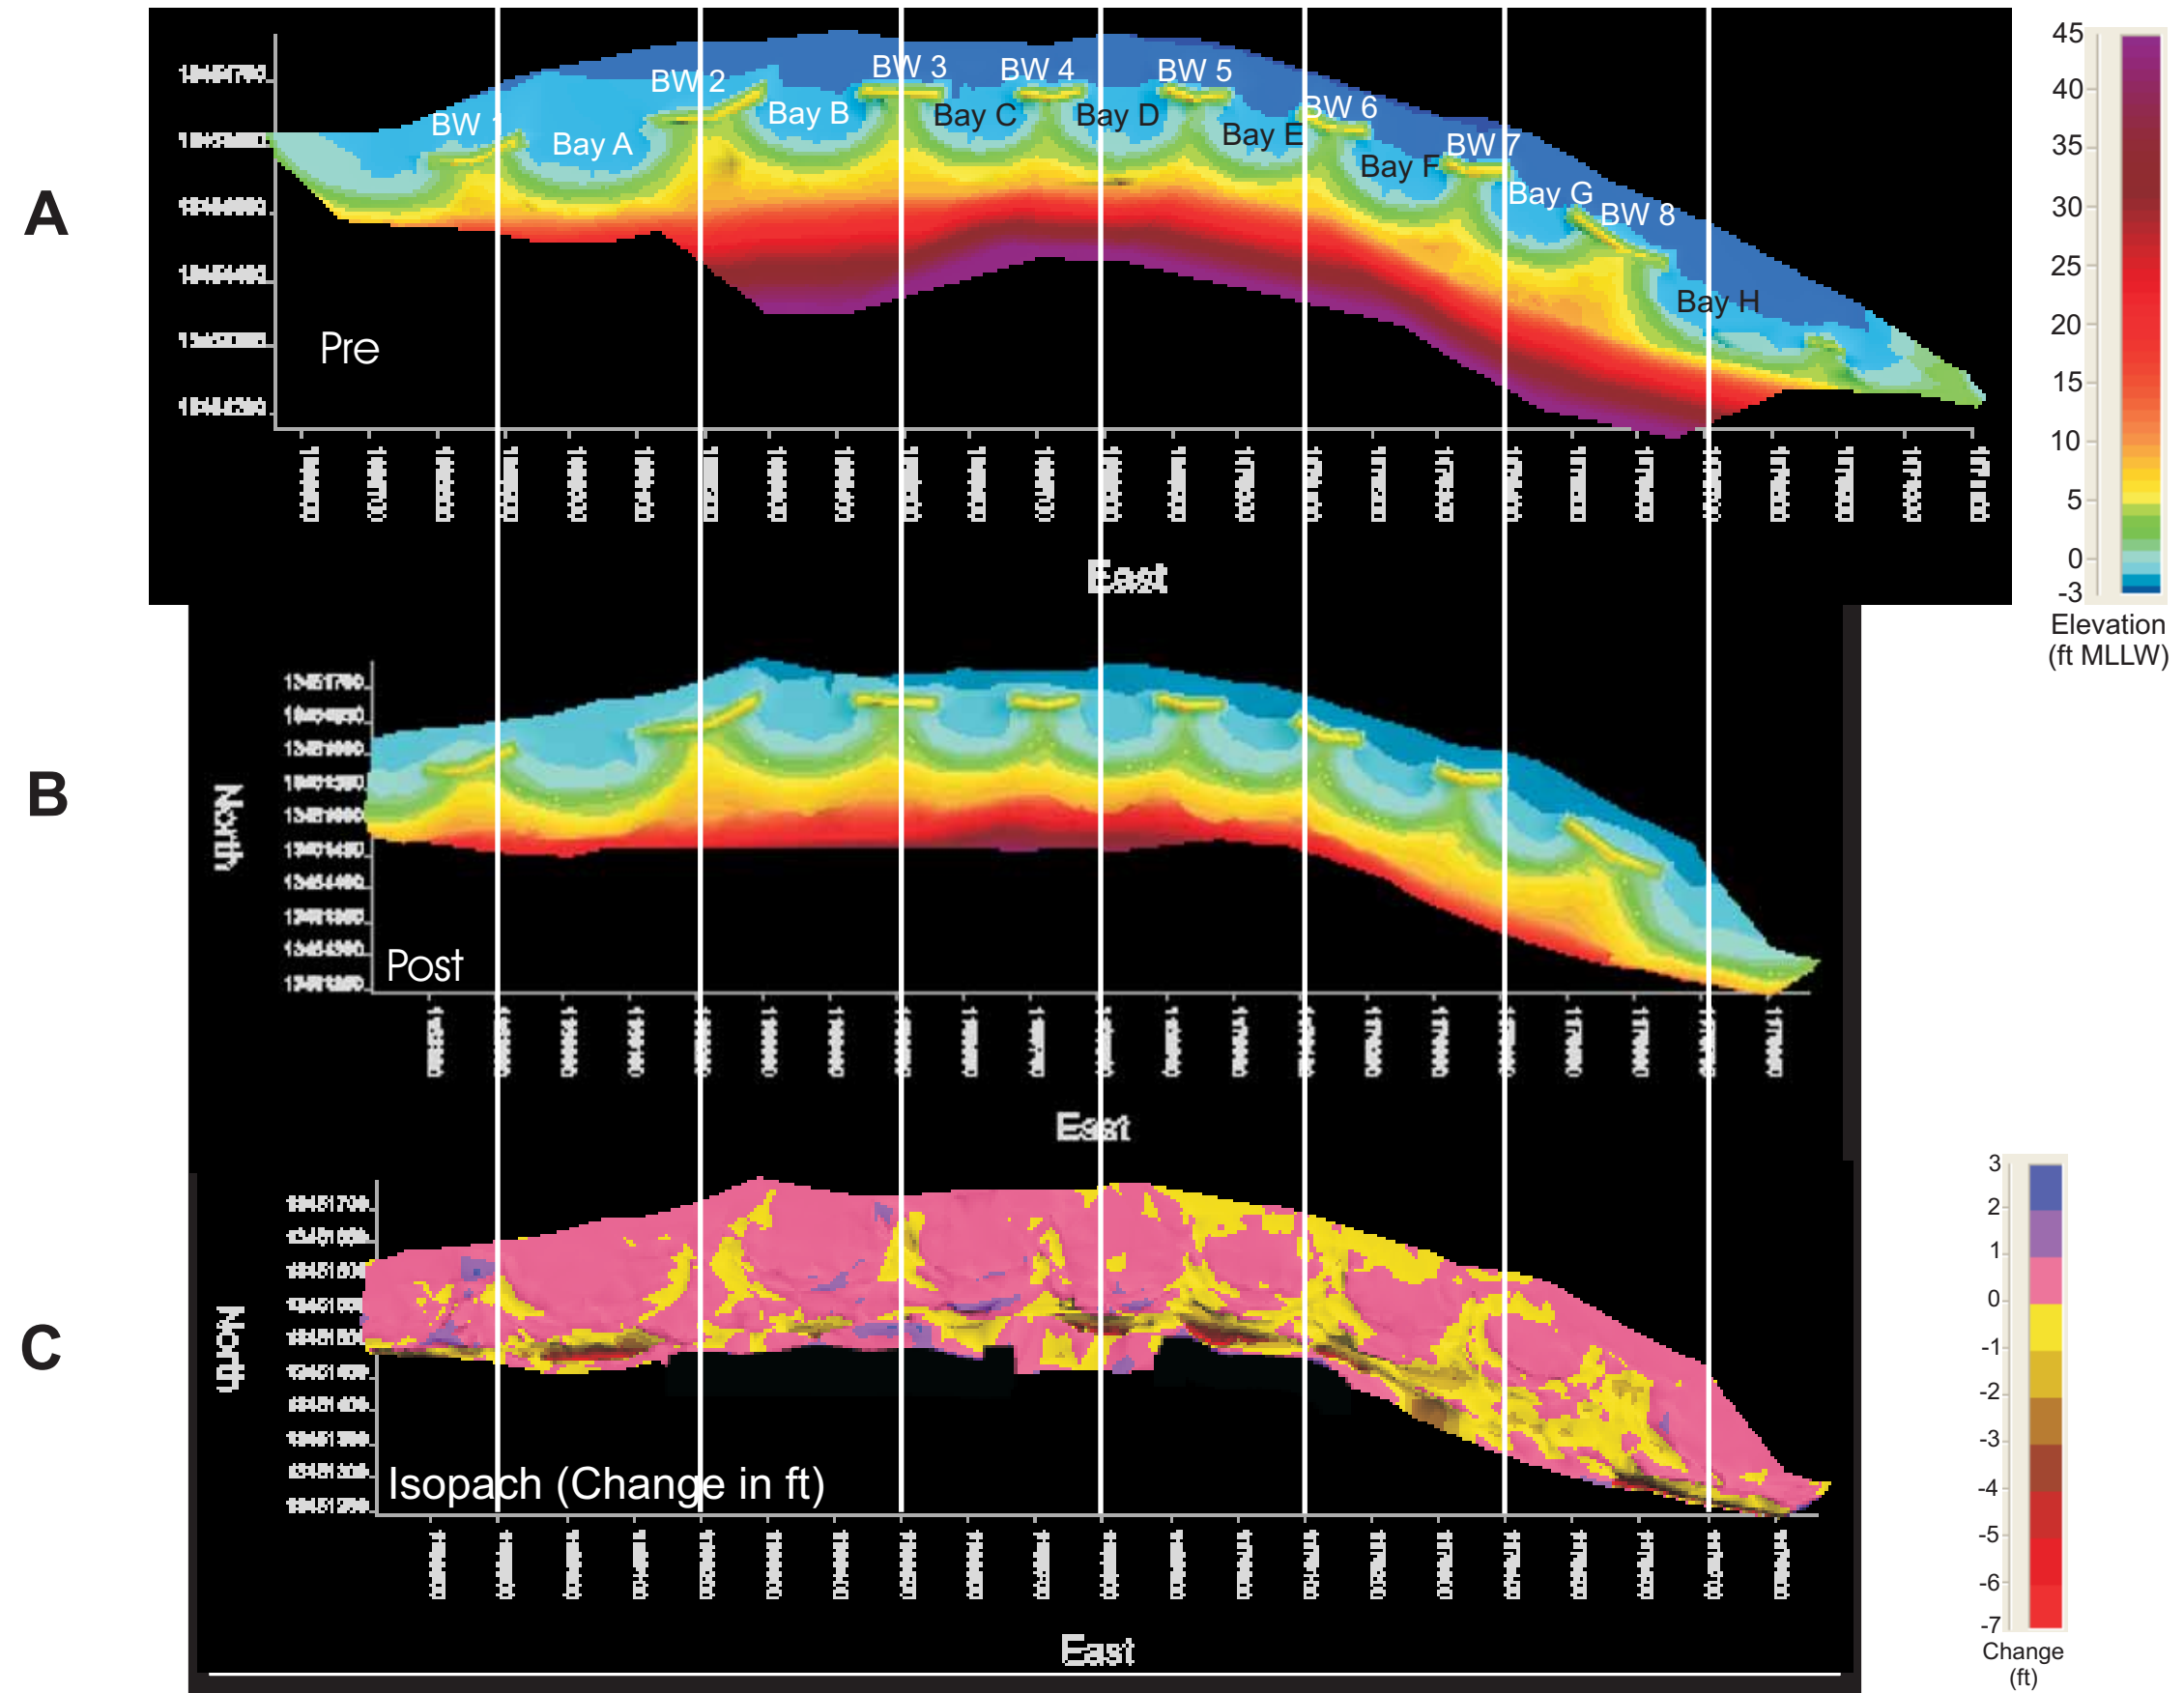
Figure 26. Van Dyke A) pre- and B) post-storm color contour maps, and C) isopach map showing elevation changes between surveys.

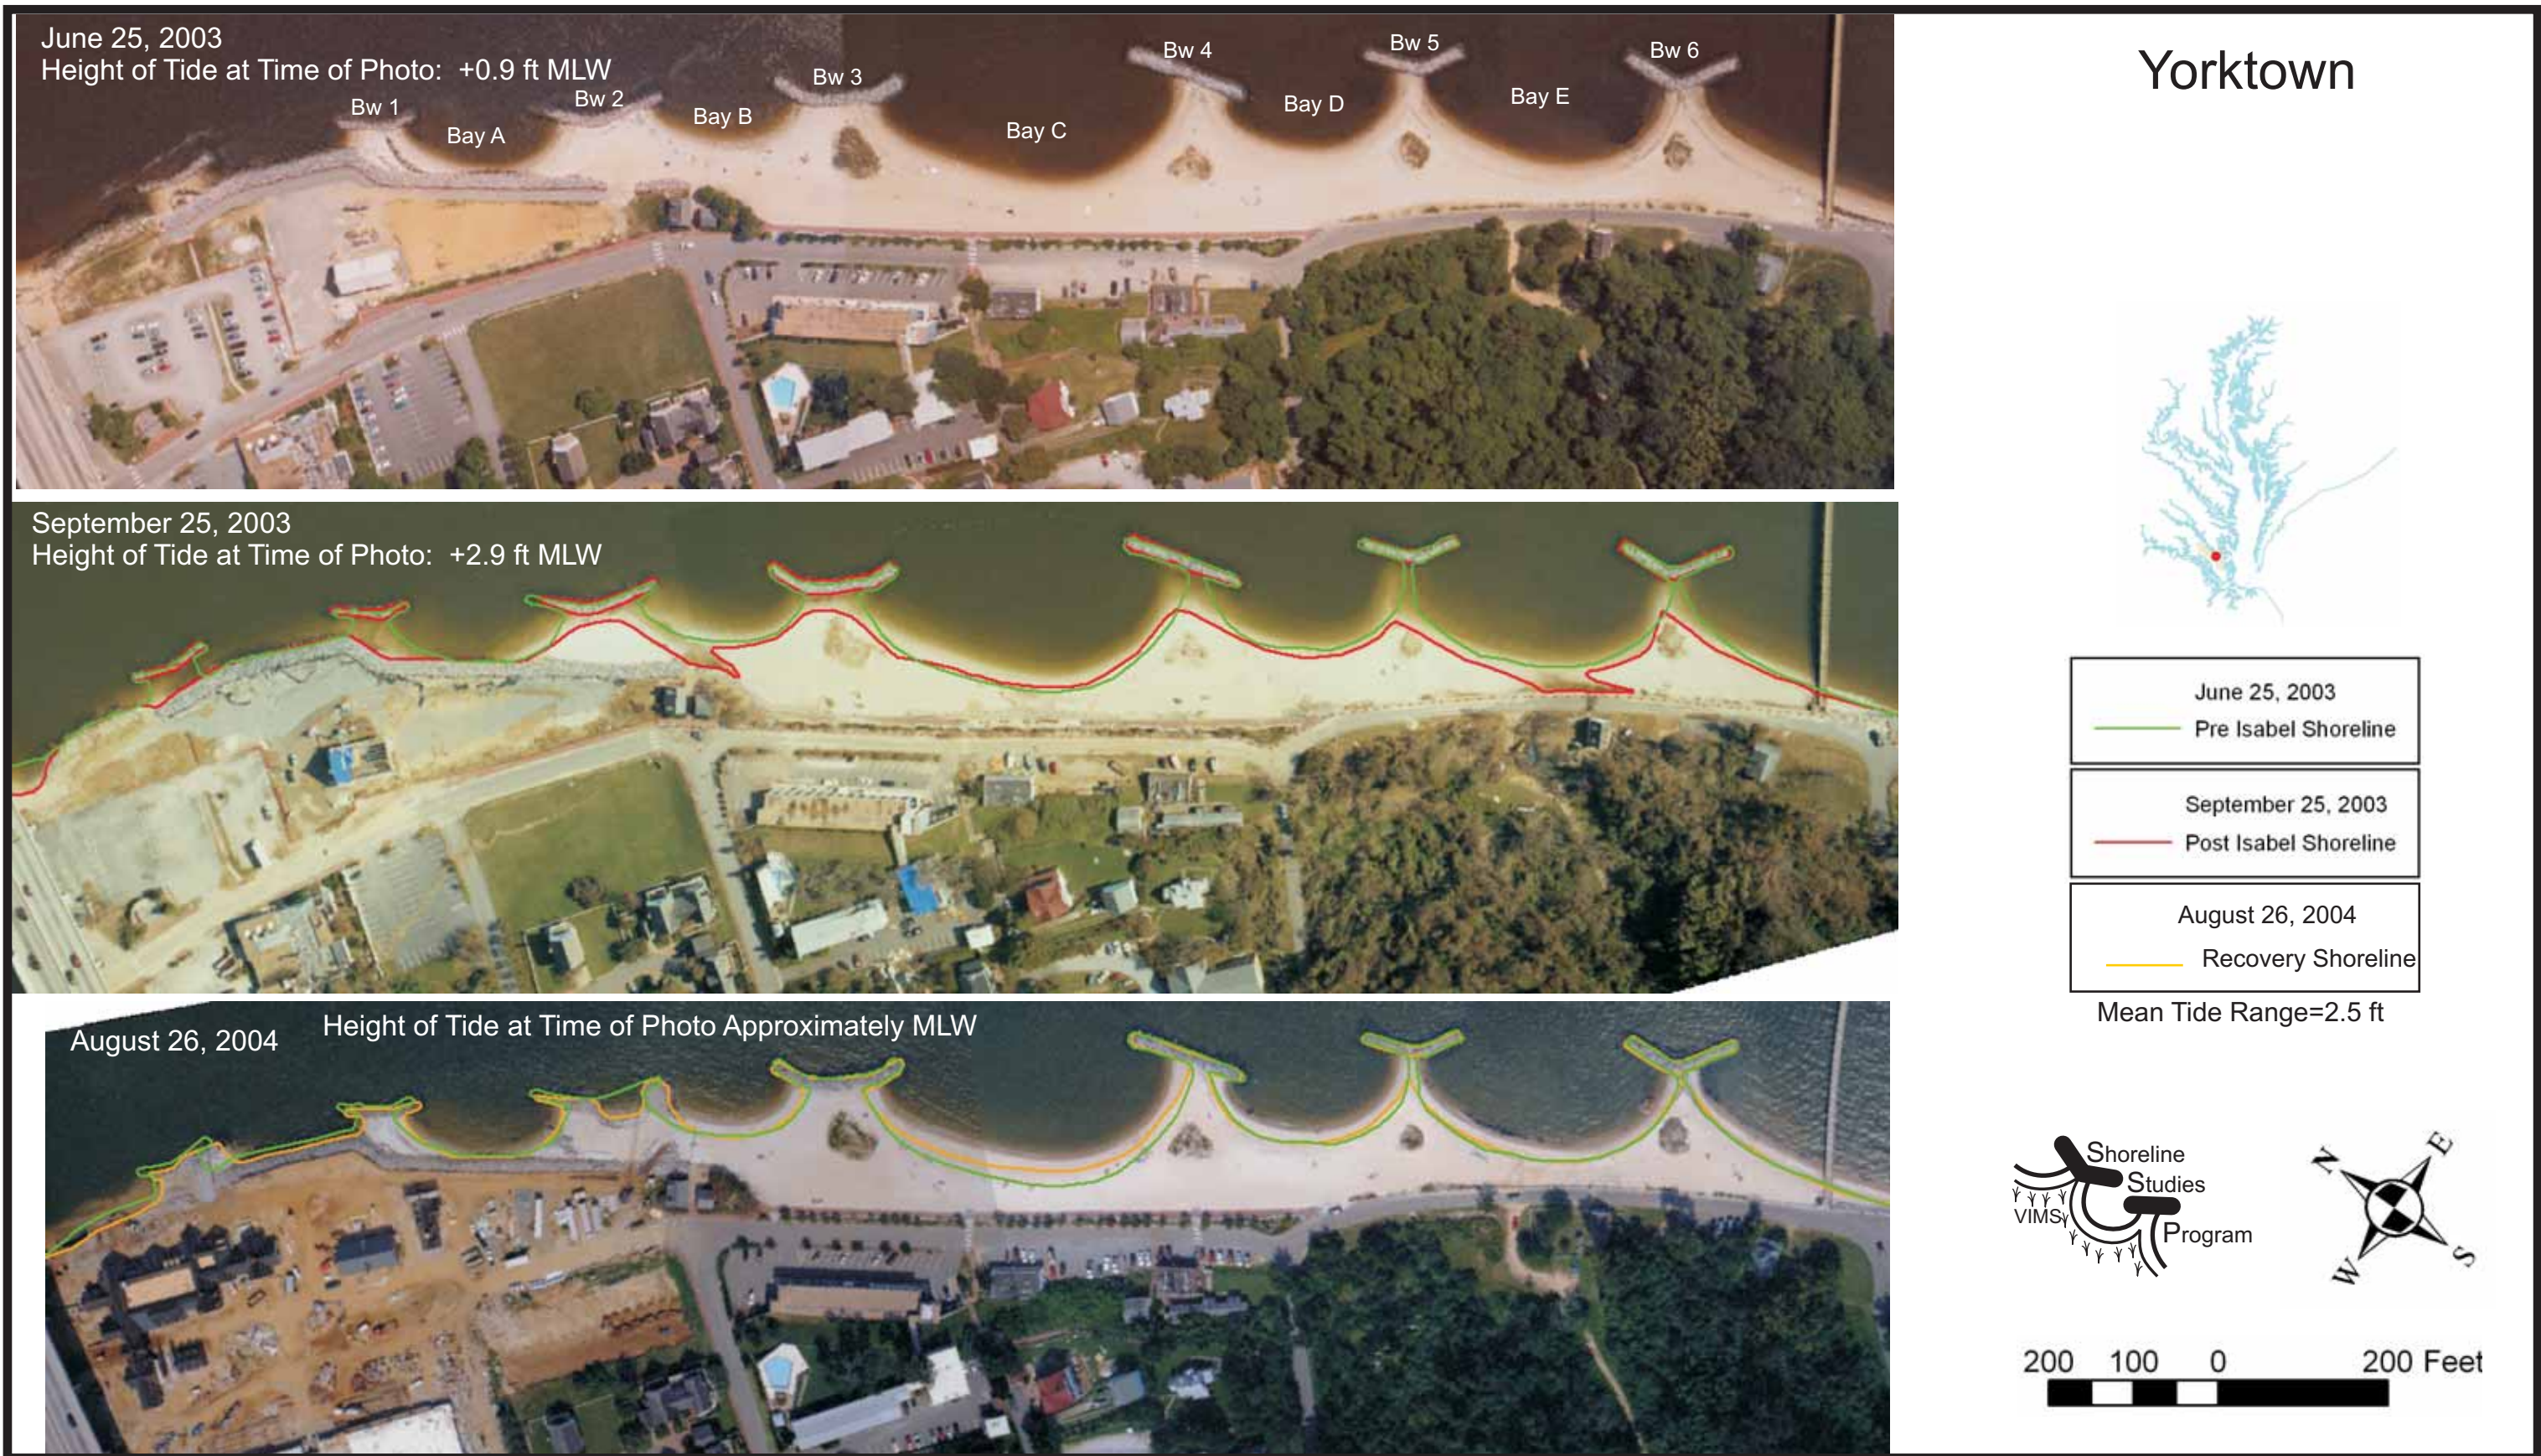
Figure 27. Yorktown low-level pre- and post-Hurricane Isabel and recovery ortho-rectified aerial photos.

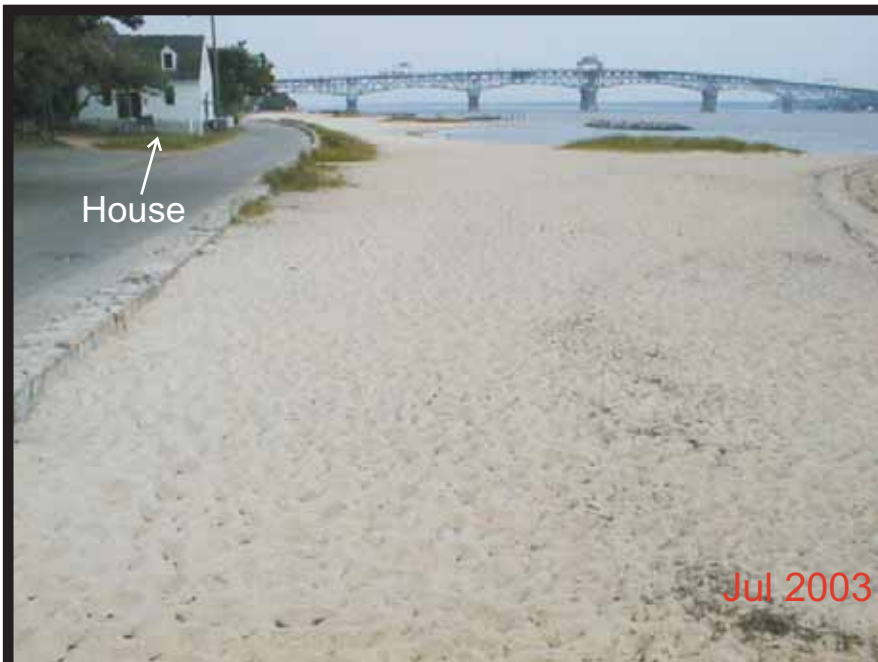
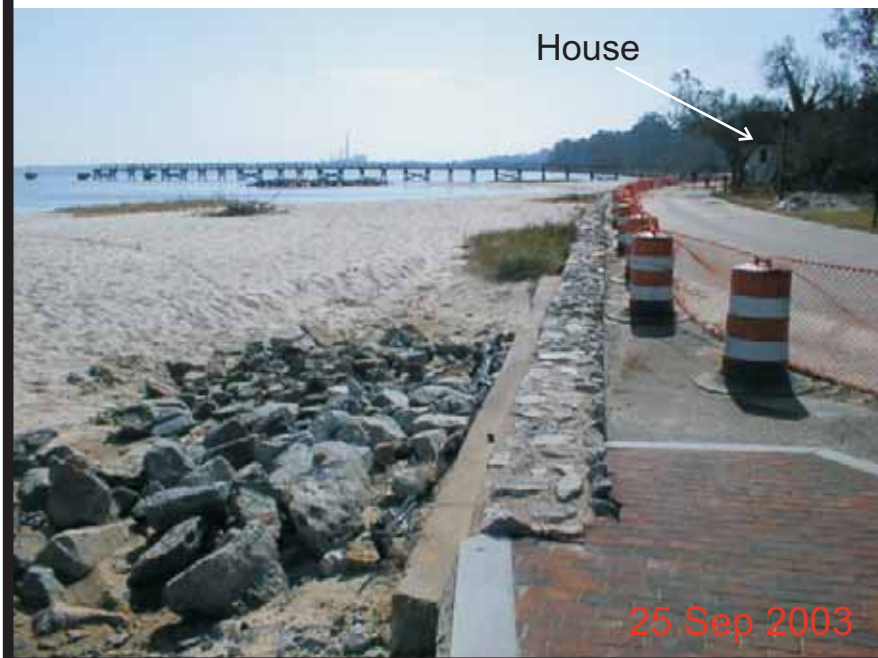
View along the downriver portion of Water Street

Sand was carried into the adjacent street but recent granite block "backstops" helped reduce this tendency. These blocks measuring about 1 ft square, 5 feet long, and weighing about 1 ton were easily shifted around by the storm waves. Several areas of scour occurred along the backshore/sidewalk/road juncture (Figure 29), but post storm clean up and added fill restored the public beach to use by late October 2003. The businesses along the waterfront were severely impacted, and it took several months for their rehabilitation due to water damage, but they are presently operating. Figure 30 shows a low backshore along Water Street in Yorktown as well as the storm wrack lines. At Colonial National Historical Park, just downriver from Yorktown, small rocks from the revetment along the shoreline were scattered on the road, and the adjacent upland bank was severely scarped.

Figure 29. Yorktown ground photos before and after Hurricane Isabel.

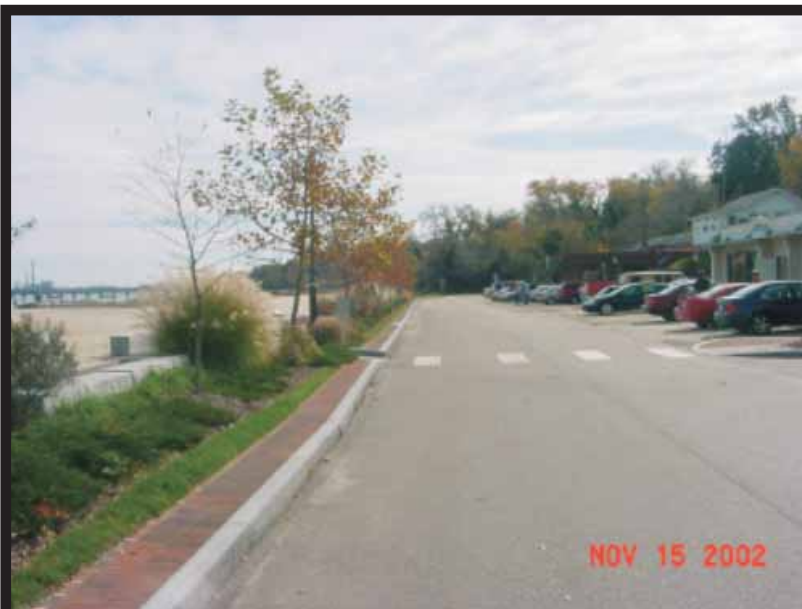
A
Pre-storm
low backshore

Figure 30. Yorktown A) backshore and B) post storm wrack line and C) adjacent shore impacts.

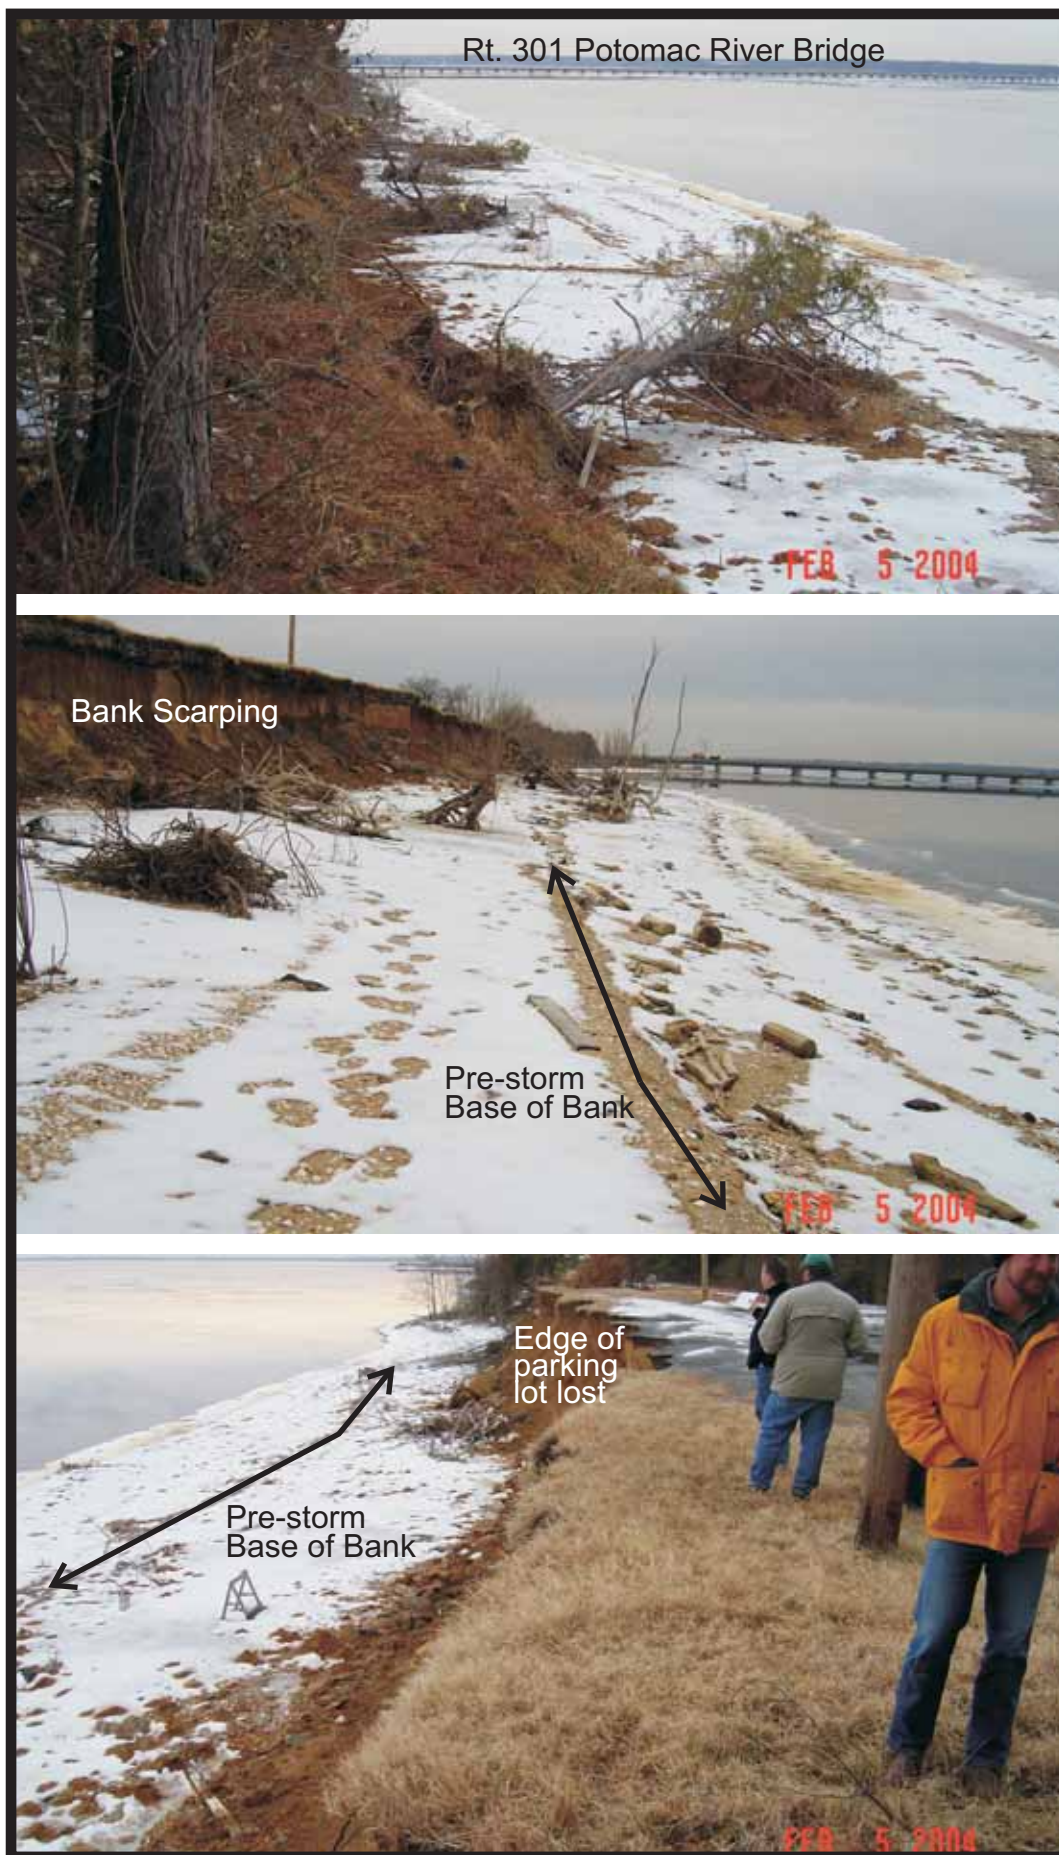
Figure 32. Impacts to the unprotected shore at Dahlgren due to Hurricane Isabel.

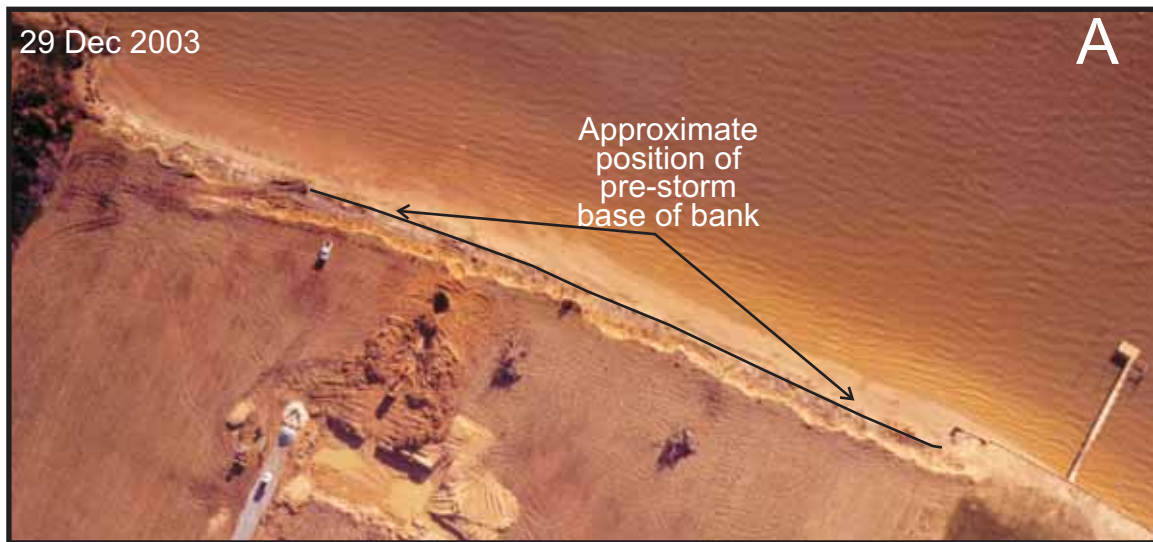
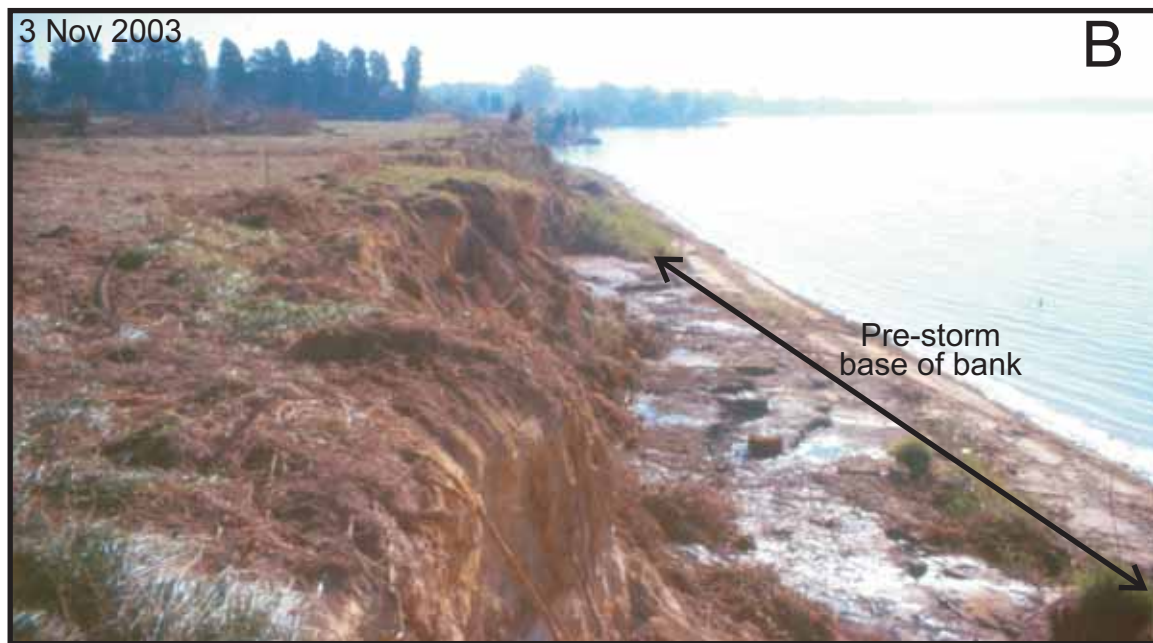
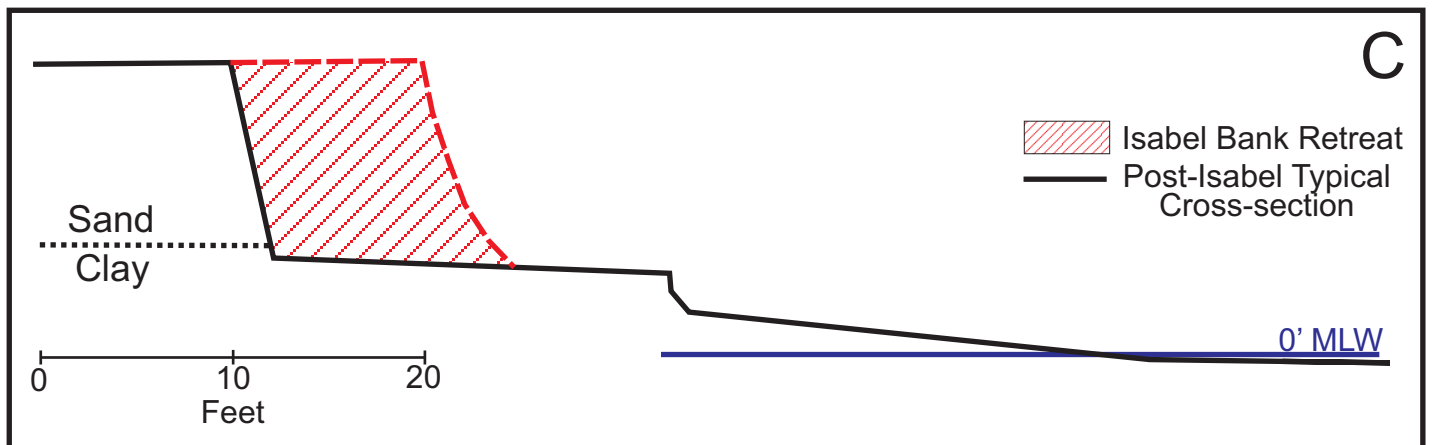
Figure 33. Impacts to the unprotected shore at Lenhart due to Hurricane Isabel shown A) on a non-rectified aerial photo, B) ground photo, and C) on a typical post-storm cross-section.

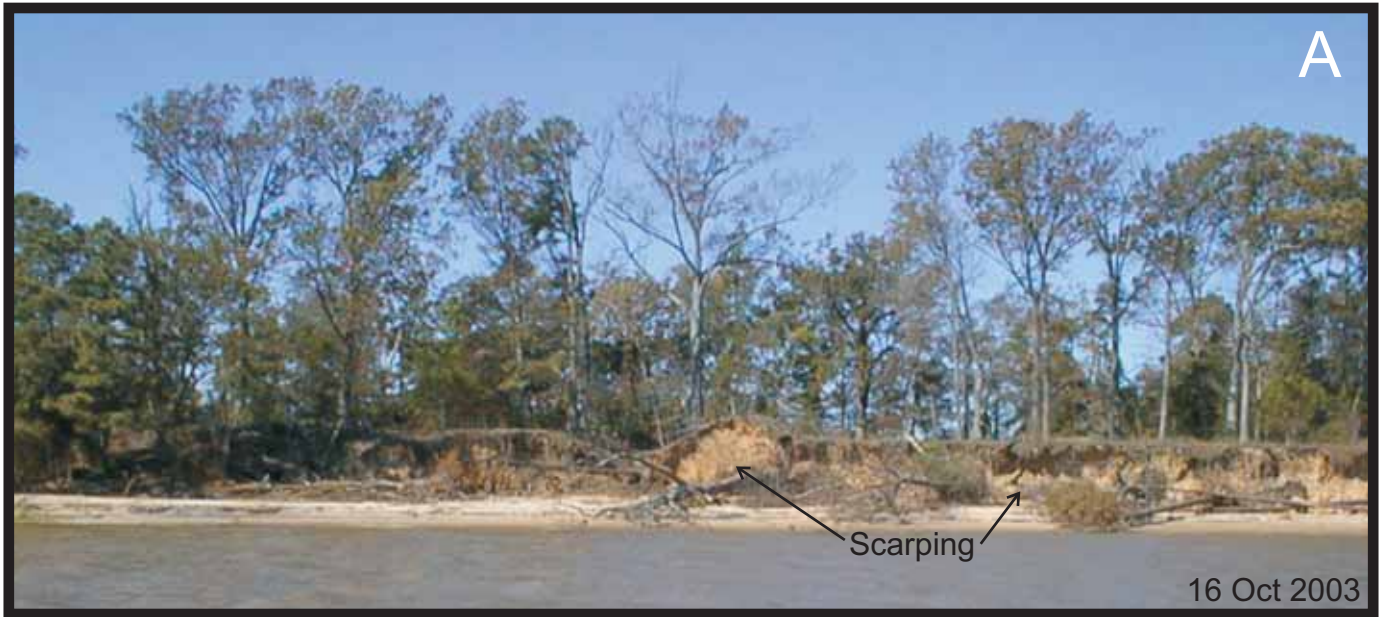
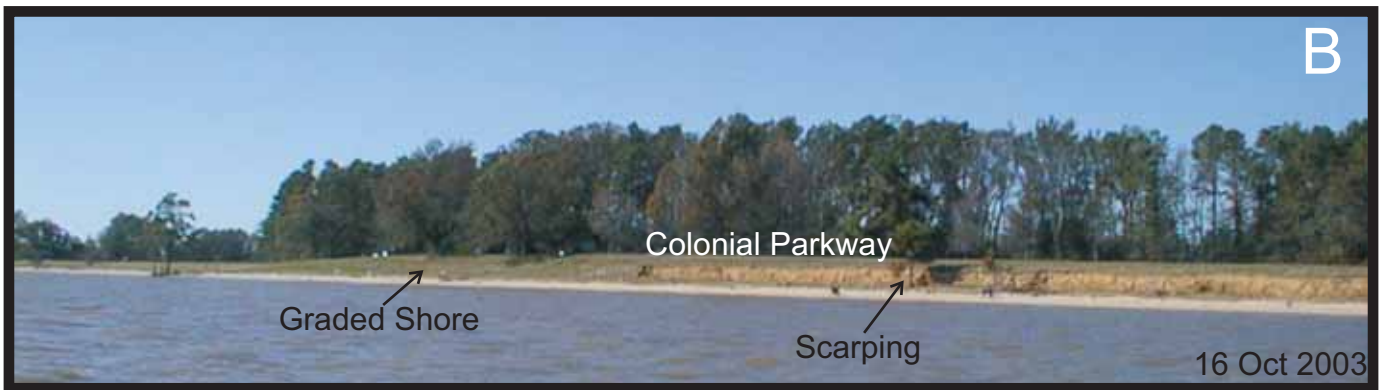
Figure 34. Impact to unprotected shores on the James River due to Hurricane Isabel A) at the Confederate Fort and B) along the Colonial Parkway.

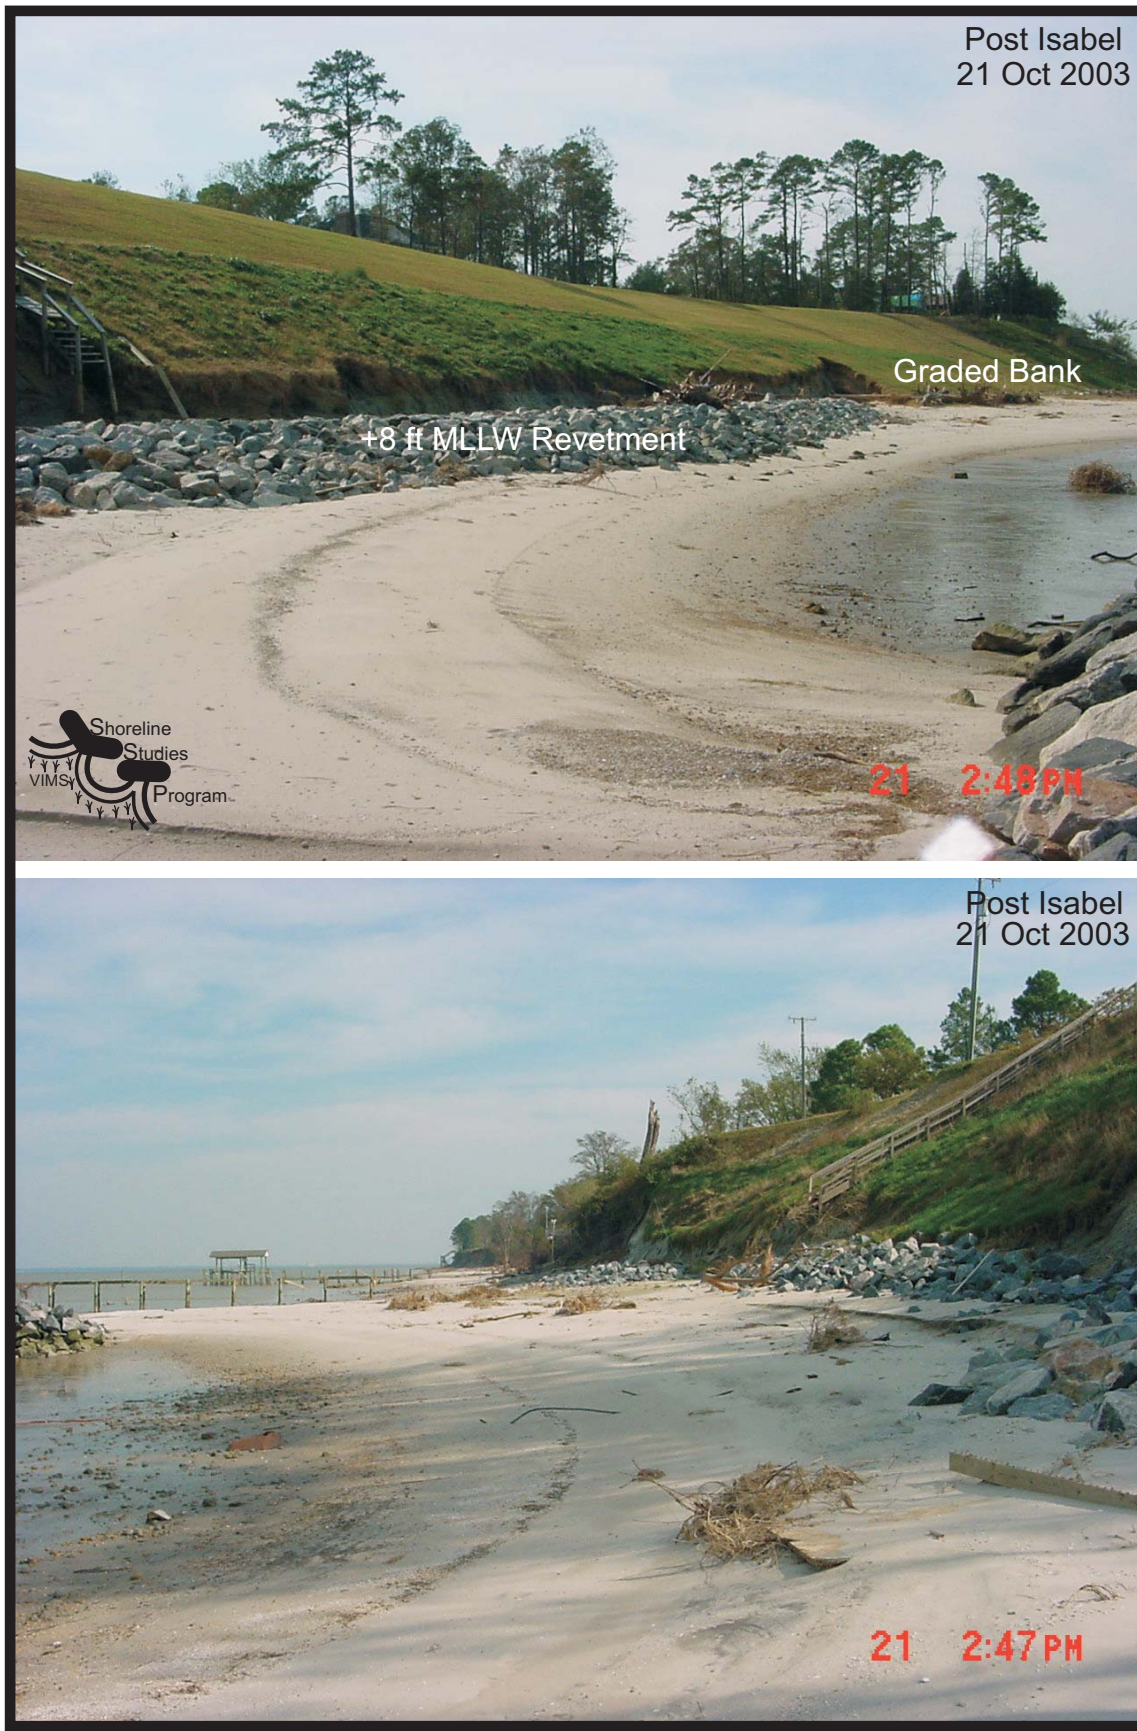
Figure 35. Impacts at the downriver end of Van Dyke where the shore is protected by a revetment.

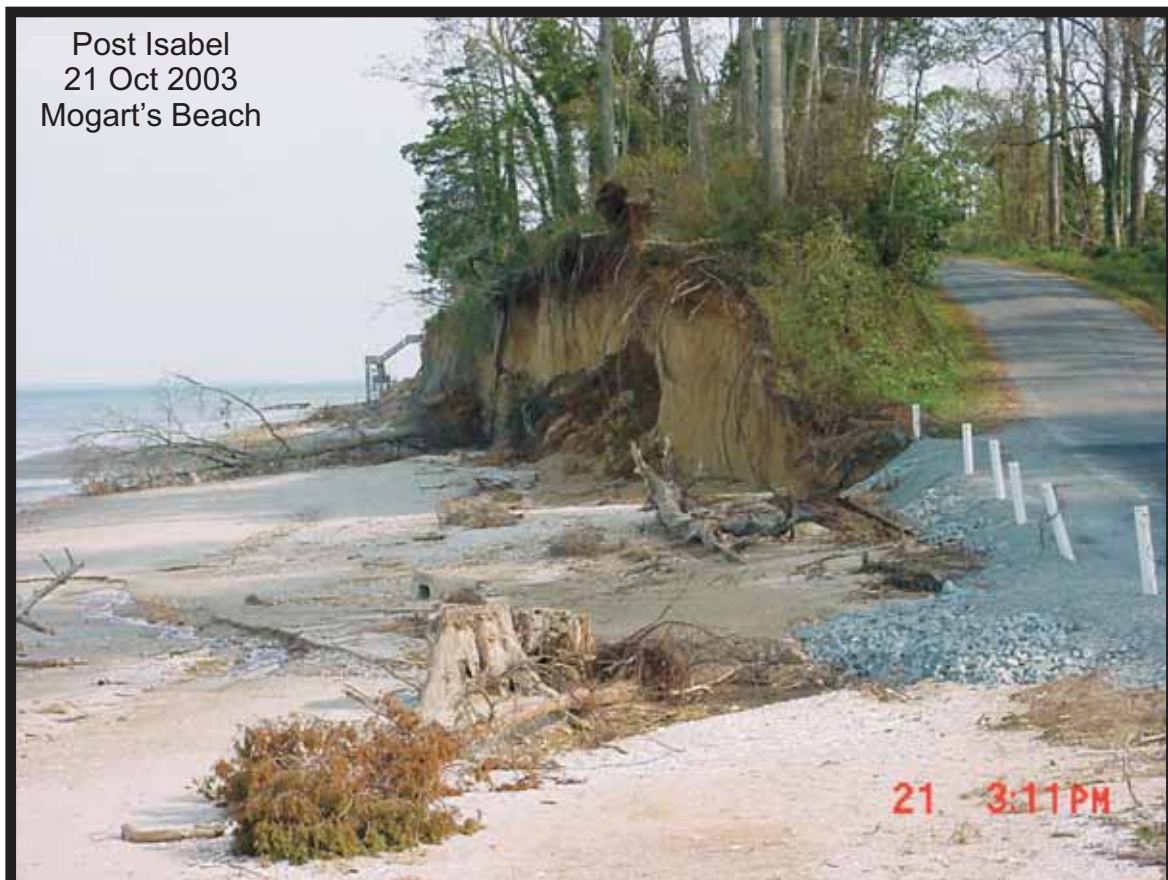
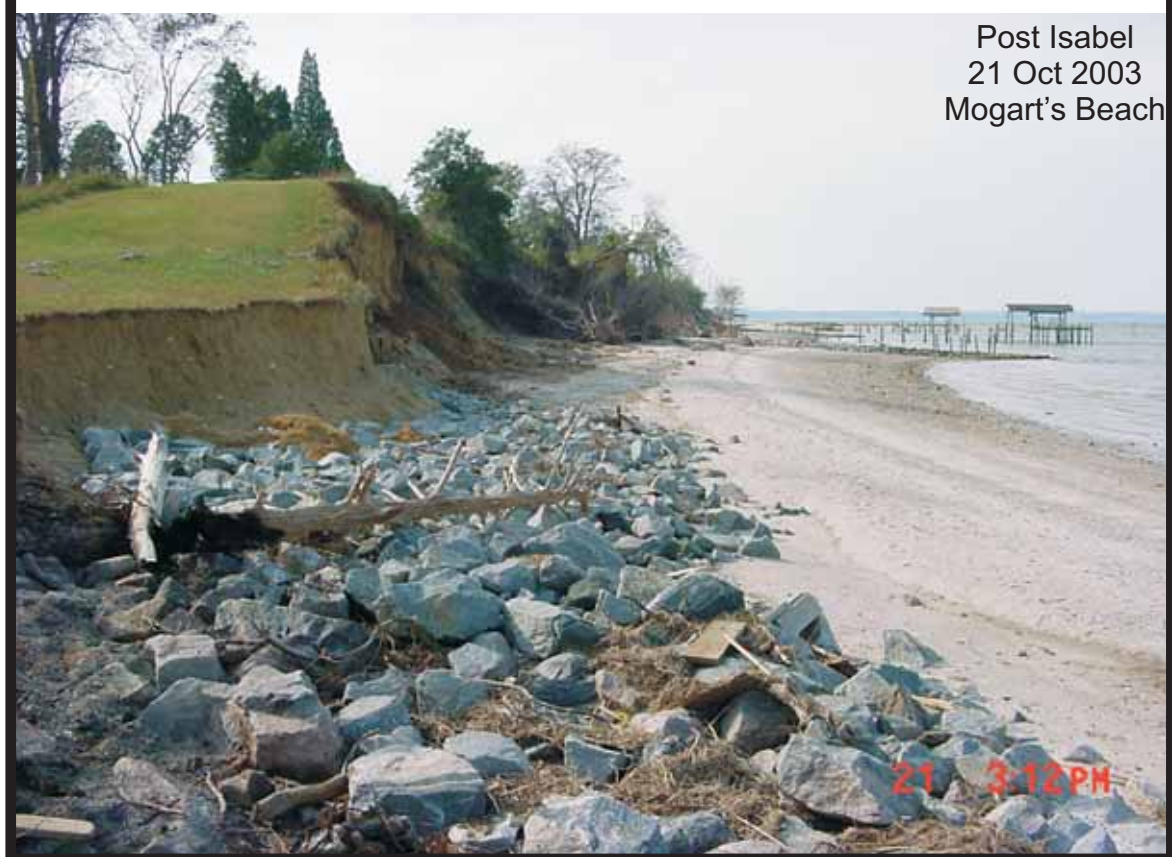
Figure 36. Impacts to the shore downriver from Van Dyke at Mogarts Beach.
